HYDRO AFRICA 2003

**REHABILITATION OF KIDATU POWER PLANT IN
TANZANIA
THE SALIENT FEATURES**

Kidatu Hydropower Plant, Tanzania

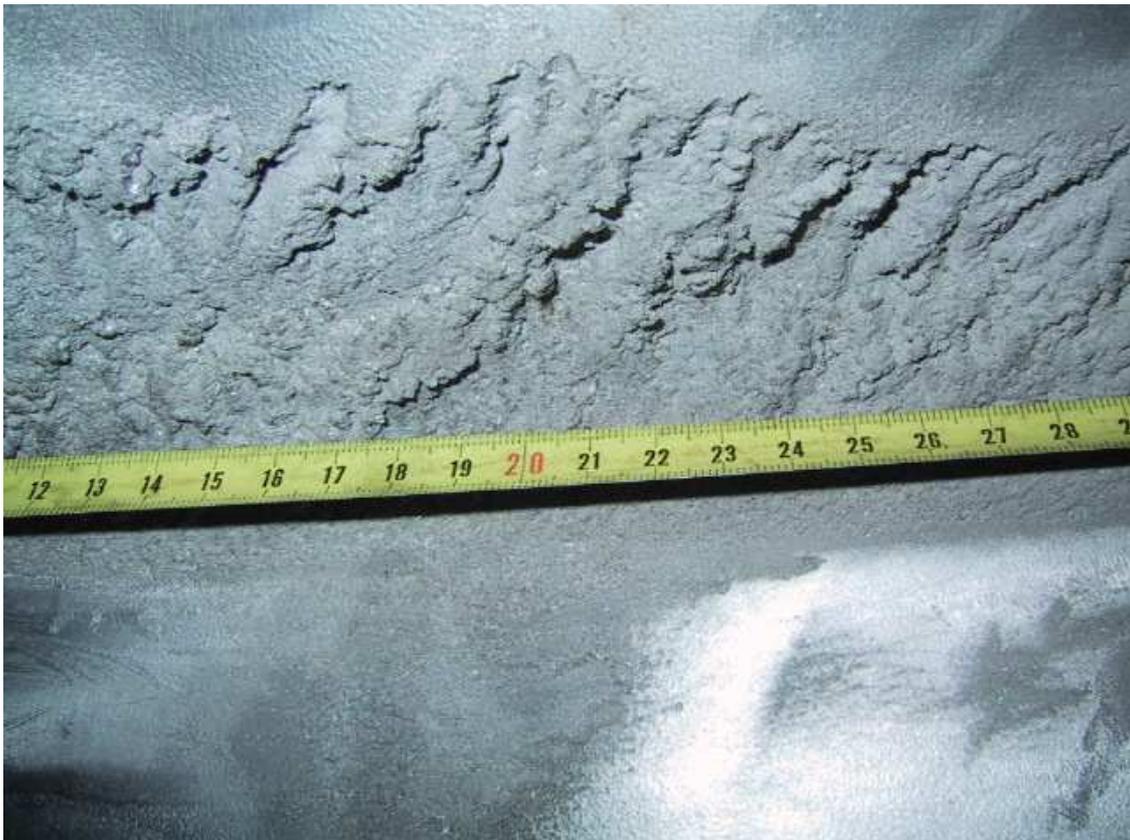
Cavitations damages on runners for unit 1 and 2 were found to be severe and considerable repairs were recommended.

Fig.1 Outlet Cavitations Damage on one of the runner blades

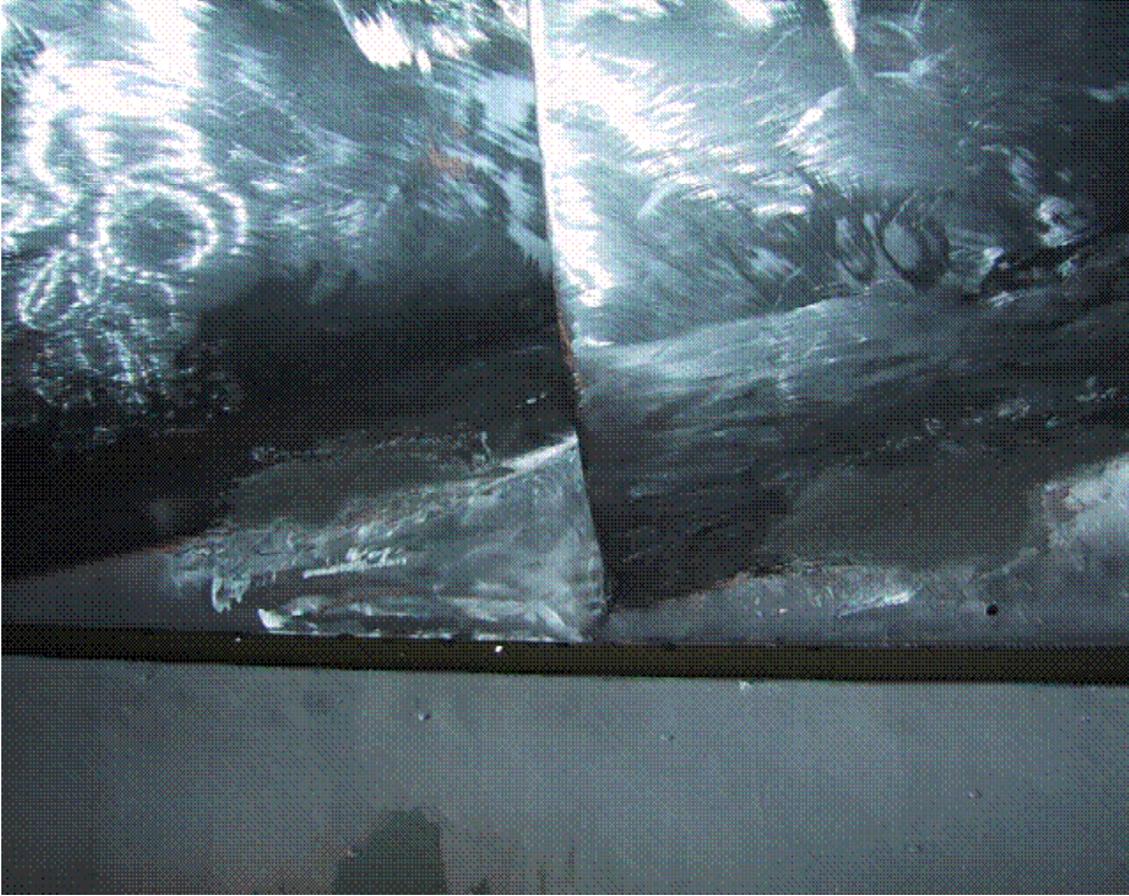
Fig 5.Condition of runner blades after repairs

Fig 5.Runner 2 outlet after repair
