HYDRO AFRICA 2003

**REHABILITATION OF KIDATU POWER PLANT IN
TANZANIA
THE SALIENT FEATURES**

Kidatu Hydropower Plant, Tanzania

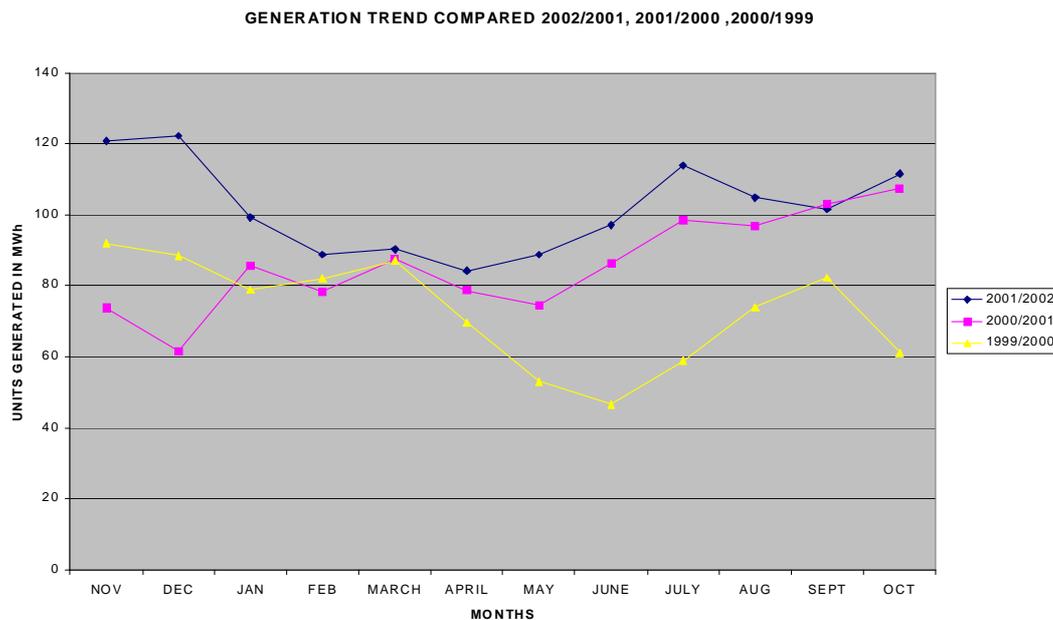
The available power generation capacity was increased from 175 MW to 200 MW, which represents an additional generation capacity of 25 MW. This additional generation capacity is deeply needed both for peaking power and as base-load during the rainy seasons. Since commissioning, the rehabilitated units have been operated continuously on almost full load at 50 MW, representing an increase on annual production of up 15%. In monetary terms the increase in energy earns about 12,6 million US\$ making it unnecessary to purchase power from thermal sources like IPTL at about 10 million US\$ annually.

Fig.1 Output improvement trend in recent years during rehabilitation

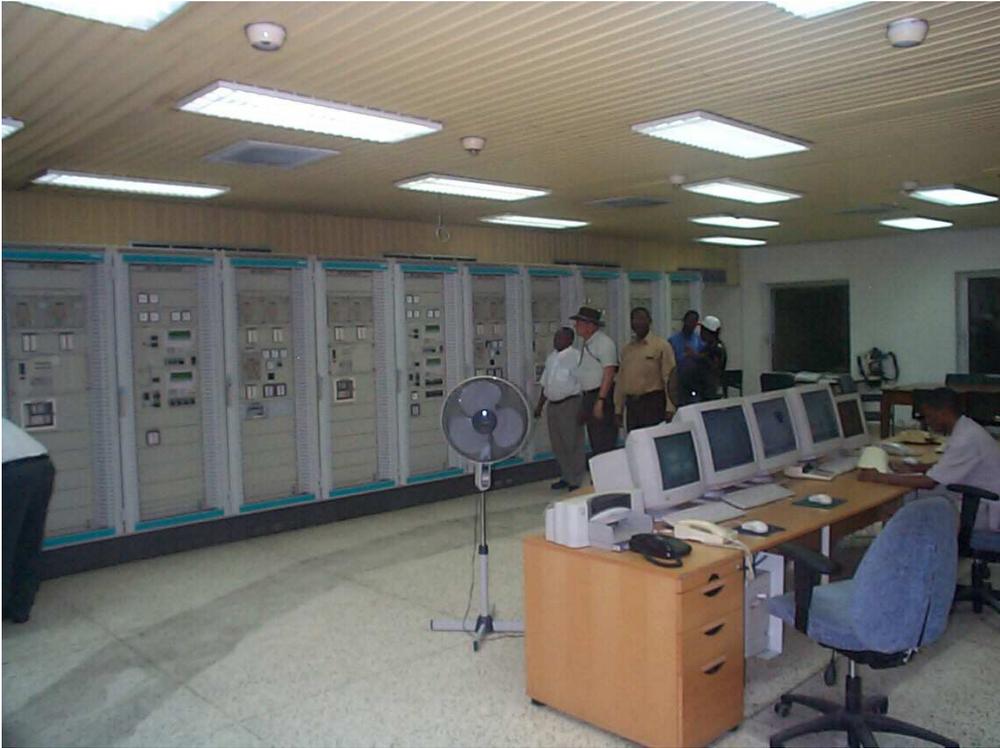
Many defects were noted on the plant control system. Some of the electromechanical relays were malfunctioning, presenting an operation risk on the reliability of the system. Lack of spare parts for the components that had been in operation of over 25 years was also distinguished as a major risk

Fig 4.New Computerized Control Room

Consequently, it was concluded to carry out a complete replacement of the conventional technology based control and protection system to an almost 100% Computerized Control System.
